# Property Inspection Report

123 Somewhere St  
West Vancouver  
25 July 2017  
Prepared for Some Body

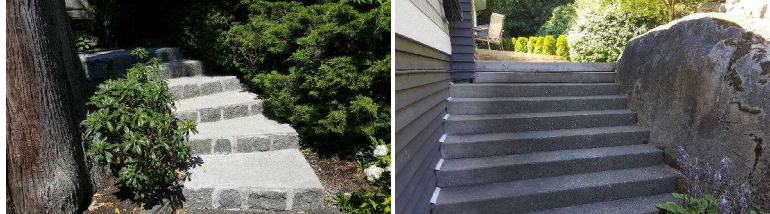
Railings (Exterior): Satisfactory, Missing - **Missing handrails. Have a professional contractor install railings for safety.**

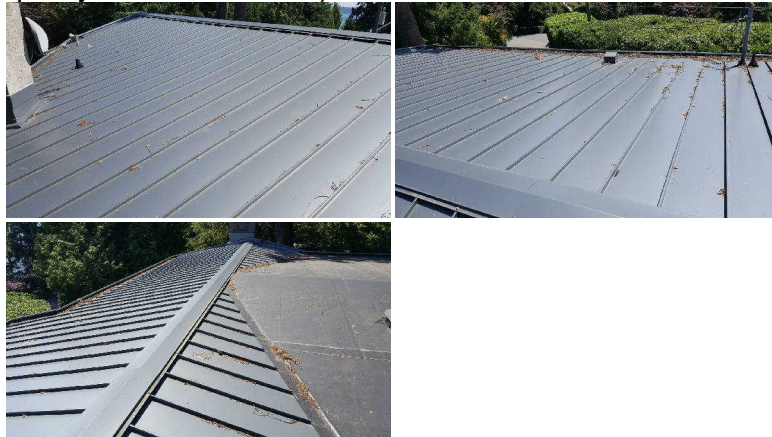
Material: Standing-seam Metal Roofing - Standing seam metal roofing is considered a premium quality roofing system. With proper periodic inspection and maintenance, a 30-50 year service life can be expected (depending on the quality of the metal used).

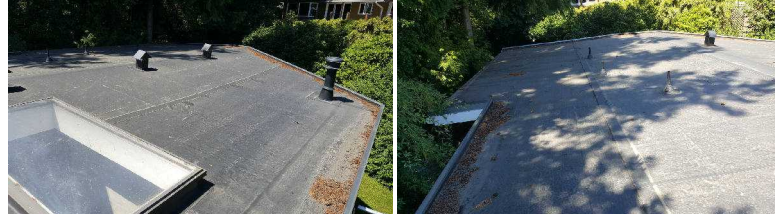
Material: EPDM membrane - Low slope roof areas should be periodically inspected by a qualified roofer and minor wear and tear and deficiencies addressed in order to ensure full service life of roof is realized.

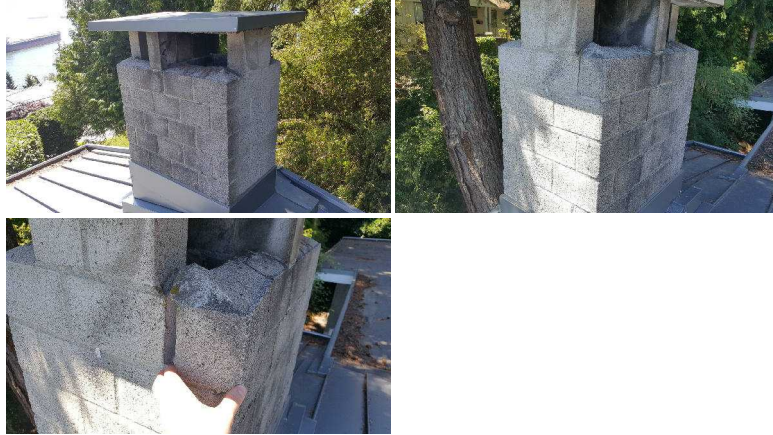
West Chimney  
Needs Repair

Chimney: Block - The block at the top of the chimney is loose. Have a professional contractor further evaluate and repair as necessary.

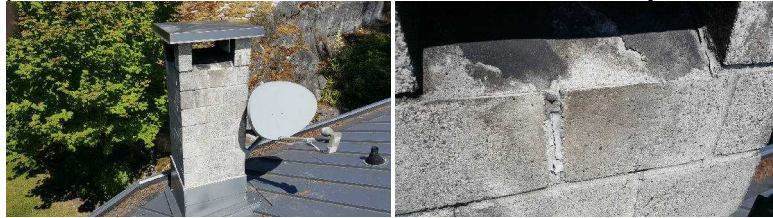
Northeast Chimney  
Inspected

Chimney: Block - Chimney will require tuck point repairs (re-pointing) at some point in future - monitor and maintain as necessary.

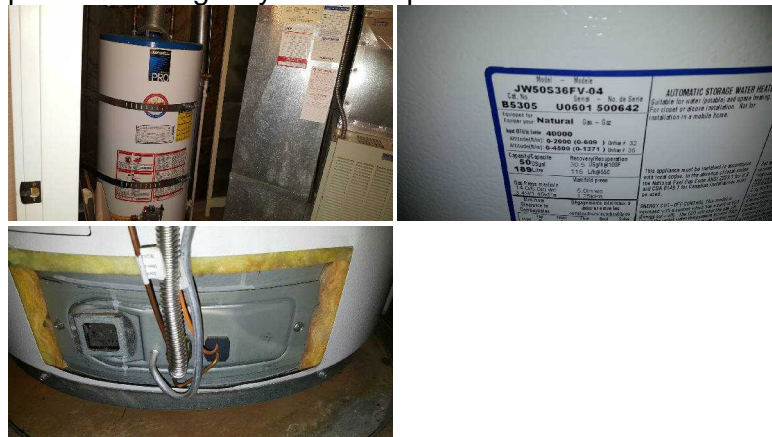
Water Heater Operation: Functional at time of inspection - Typical hot water tank service life in area is approximately 8-10-12 years. Warranty for this unit is eight years. As warranty period has expired, it would be prudent to maintain a 100 percent contingency fund for replacement.

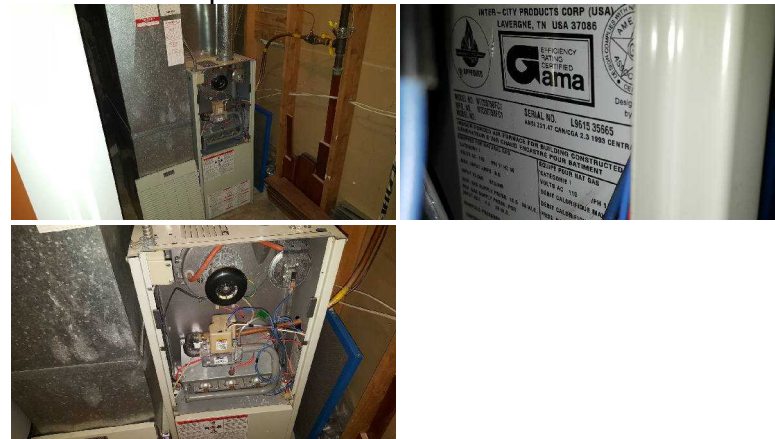
Inspected Furnace Operation: Adequate - Disclosed that system was serviced approximately a year and half ago. Recommend to verify that this is the case. Typical manufacturer's recommended service interval is annual to ensure proper functionality and reliability.

Age of furnace is such that appropriate contingency funds should be maintained for maintenance and future replacement/upgrading. Consult your heating contractor for options and costs.

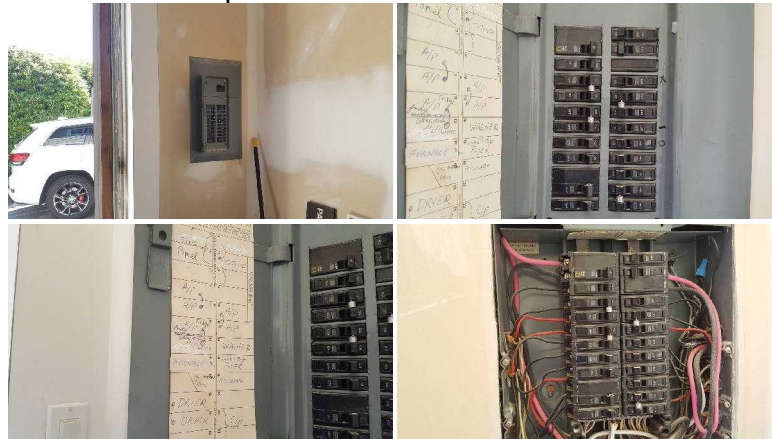
Garage Electric Panel  
Inspected

Manufacturer: Square D

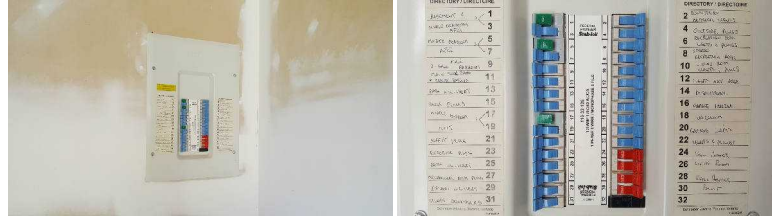
Maximum Capacity (Estimated): 125 Amps  
Main Breaker Size: 40 amps at main panel  
AFCI: 110 volt - Manufacturer recommends operating test button monthly (push button, breaker handle should trip to intermediate position - to reset, push breaker handle fully 'off' then push back to original/on position). Contact an electrician if the breaker fails to trip when test button is depressed.

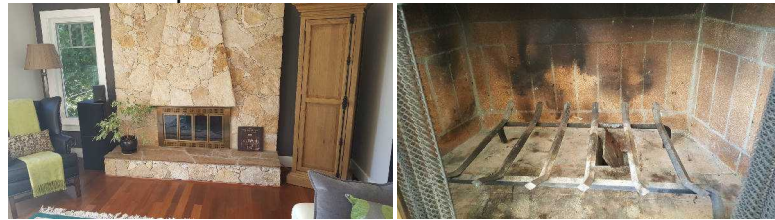
### Living Room Wood Burning Fireplace

Inspected	Fireplace Construction: Manufactured - The fireplace and components apparently have been recently cleaned and serviced. This should be completed annually by a professional fireplace maintenance company for safety and functionality.
-----------	---

Do not use without installing a safety barrier or manufacturer approved protective screen to help reduce the risk of accidental contact/serious burns.

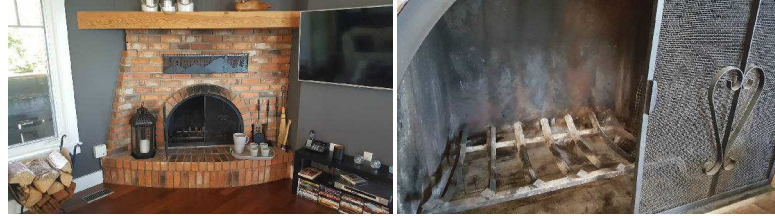
### Sitting Area Off Of Kitchen Wood Burning Fireplace

Inspected	Fireplace Construction: Manufactured - The fireplace and components apparently have been recently cleaned and serviced. This should be completed annually by a professional fireplace maintenance company for safety and functionality.
-----------	---

Do not use without installing a safety barrier or manufacturer approved protective screen to help reduce the risk of accidental contact/serious burns.

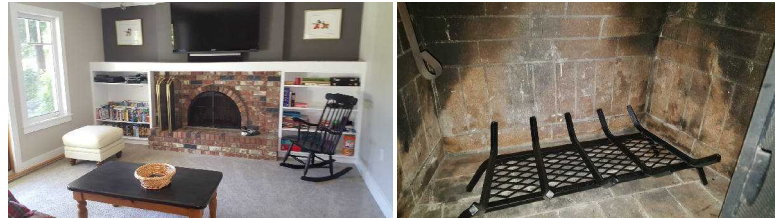
Ground Floor Sitting Area Wood Burning Fireplace

Fireplace Construction: Manufactured - The fireplace and components apparently have been recently cleaned and serviced. This should be completed annually by a professional fireplace maintenance company for safety and functionality.

There is a barrier in front of the fireplace. This is to help reduce the risk of accidental contact/serious burns.

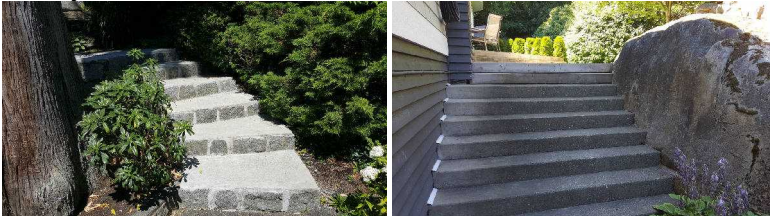
3. Railings (Exterior): Satisfactory, Missing - Missing handrails. Have a professional contractor install railings for safety.

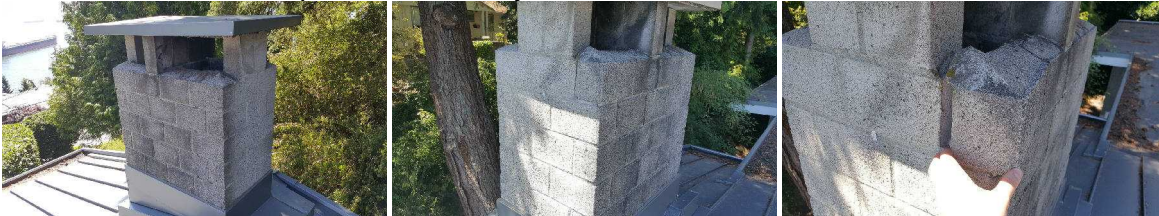
4. West Chimney Chimney: Block - The block at the top of the chimney is loose. Have a professional contractor further evaluate and repair as necessary.
